INTERIM REPORT M-336
November 1983

**CONSTRUCTION OF ALUMINUM STANDING-SEAM
ROOFING AT AN ARMY FACILITY**

by
Myer J. Rosenfield

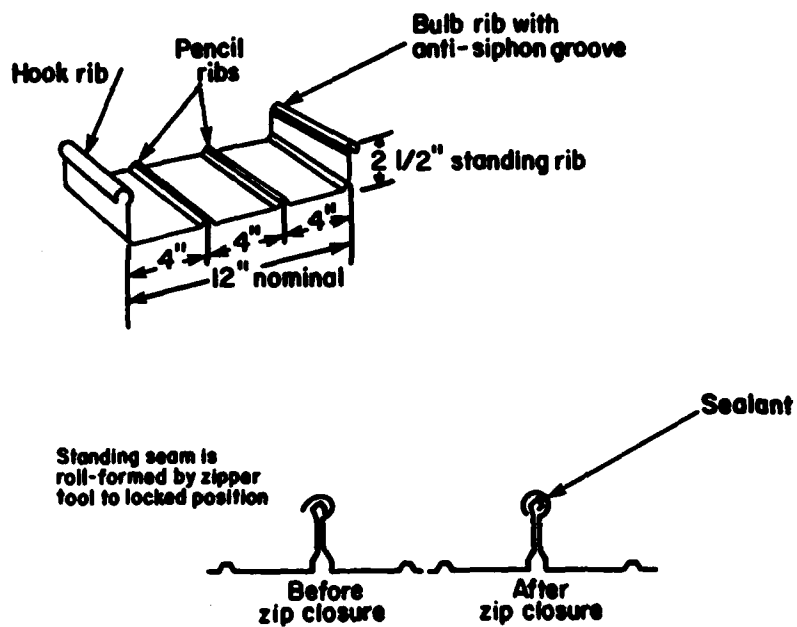
Figure 5. Detail of roofing panel.

The 80-ft (24-m) panel length is the longest standard length furnished by the manufacturer from the factory. Each panel is 1 ft (305 mm) wide, with a 2 1/2-in. (64-mm) roll-formed shape on each side. Figure 5 shows a cross section of the panel. Panels used at DCSC were .032 in. (.81 mm) thick. The sealant used was a 3/16-in. (4.75-mm-) diameter butyl strip on a release paper. When placed as shown in Figure 6, it seals the standing seam and prevents entry of wind-driven or snow-melt water into the system.

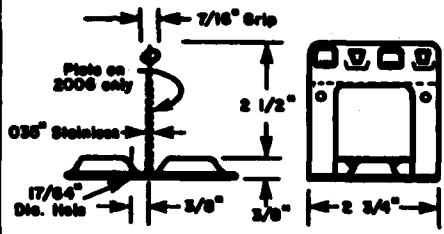
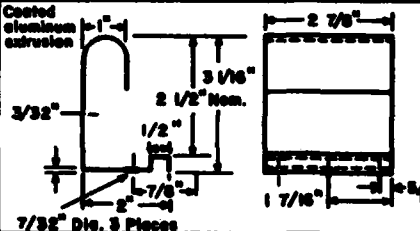
Figure 13. Panel attachment clips.

Panels are retained in place by clips screwed to the sleepers. Each clip has bulbs at the top which fit into the seam and prevent the roof panels from lifting off while permitting expansion and contraction. There are two types of clips: one is for expansion, and one serves as an anchor (Figure 13). A button punch locks the panel seams to the anchor clips. These clips were

Figure 13 also shows the clip used along the firewalls to hold the edge of the first panel under the base flashing. A stepped aluminum counterflashing was installed (Figure 14) into reglets cut into the firewall parapet. Because of the high winds that can be expected in the Columbus, OH, area, a stainless steel strap was installed to provide uplift resistance to the counterflashing. Figure 15 shows flashing details. Figure 16 shows the intersection of counterflashings at the step, including the uplift resistance strap before it was bent up. The upper sheet was locked to the lower one by cutting a slit and locking the two pieces together as shown.
